IMPROVED BIAS FOR ORIGINAL DR 103 TRANNY  
CONTROL FOR  
2 PAIR EL34

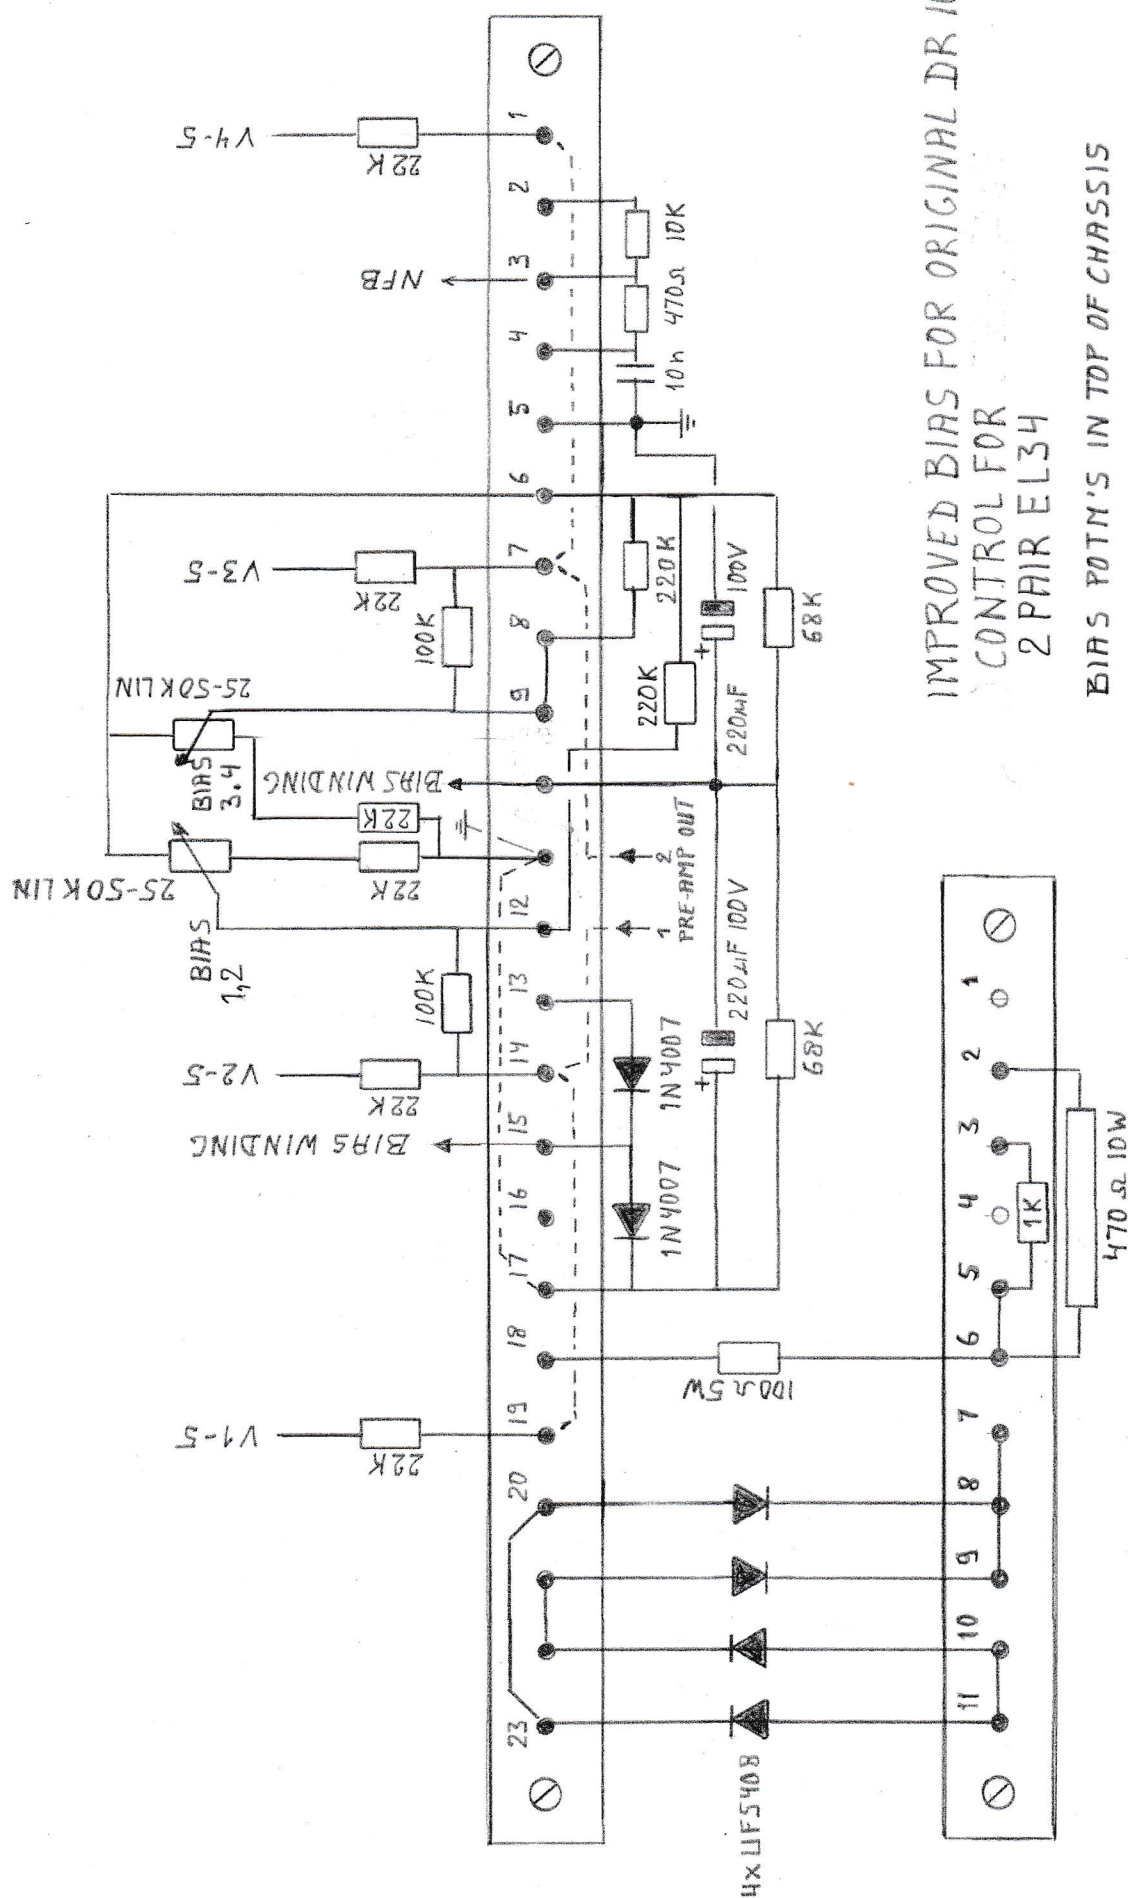
BIAS POTN'S IN TOP OF CHASSIS
